TECHNICAL REPORT GL-90-16

INVESTIGATIONS OF MAGNETIC FIELD DISTURBANCES AT LITTLE ROCK AIR FORCE BASE COMPASS CALIBRATION HARDSTAND

Geotechnical Laboratory

September 1990
Final Report

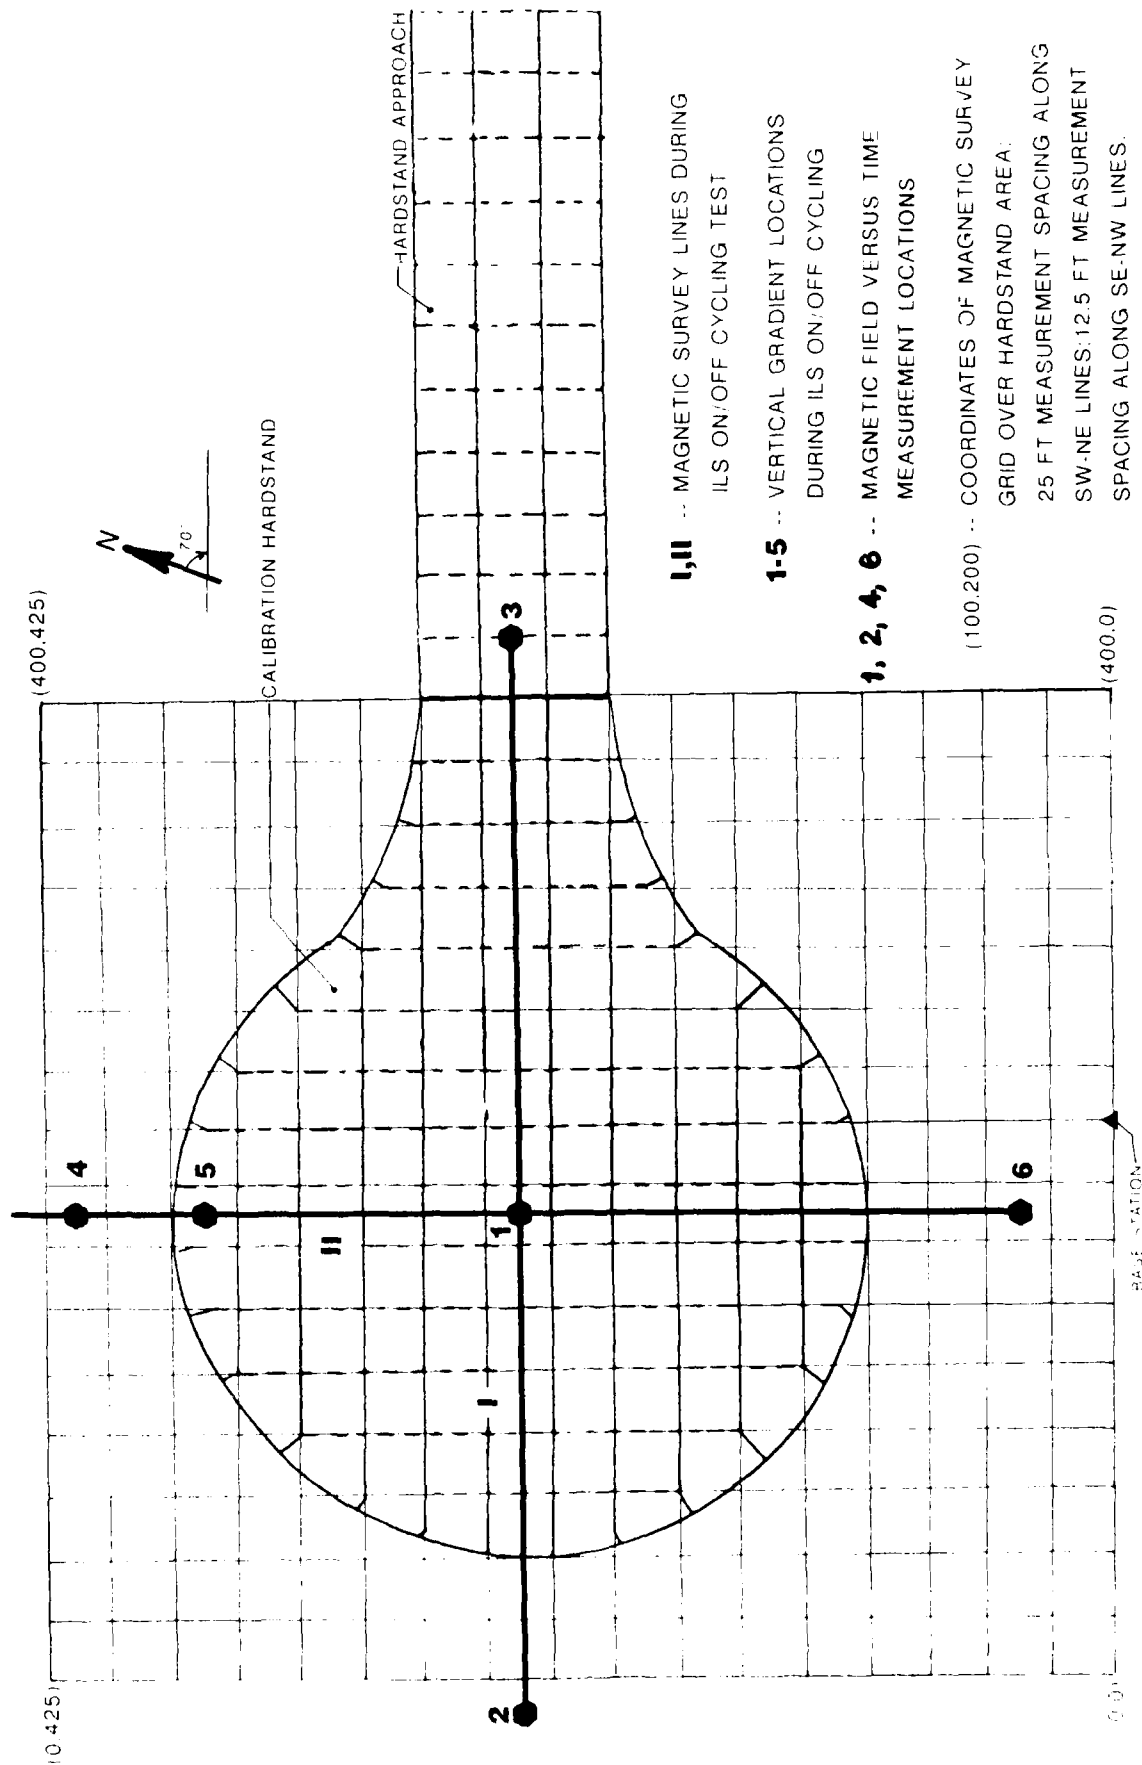
Figure 1. Survey layout at the LRAFB compass calibration hardstand

6. The layout of investigations to characterize the nature and source of magnetic disturbances at the calibration hardstand is illustrated in Figure 1. The 400 by 425 ft (122 by 130 m) gridded area was used for a survey of total magnetic field strength over the hardstand and immediate surrounding area. Measurement interval was 25 ft (7.6 m) along SW-NE lines, and 12.5 ft (3.8 m) along SE-NW lines, for a total of 595 measurements. Measurements were acquired with a digital proton precession magnetometer, which has an accuracy of 1 nT. Survey lines I and II were used to detect magnetic field effects in the hardstand area due to cycling the nearby ILS system (approach radar) on and off. Measurement interval along lines I and II was 12.5 ft. Locations 1-5 were used for magnetic vertical gradient measurements (variation of the magnetic field in the vertical direction) during the ILS on and off cycles. Locations 1, 2, 4, and 6 were used for magnetic field versus time measurements during ILS on and off cycles. Magnetic field versus time measurements were acquired with a recording proton precession magnetometer, which produces analog records on a strip chart recorder.

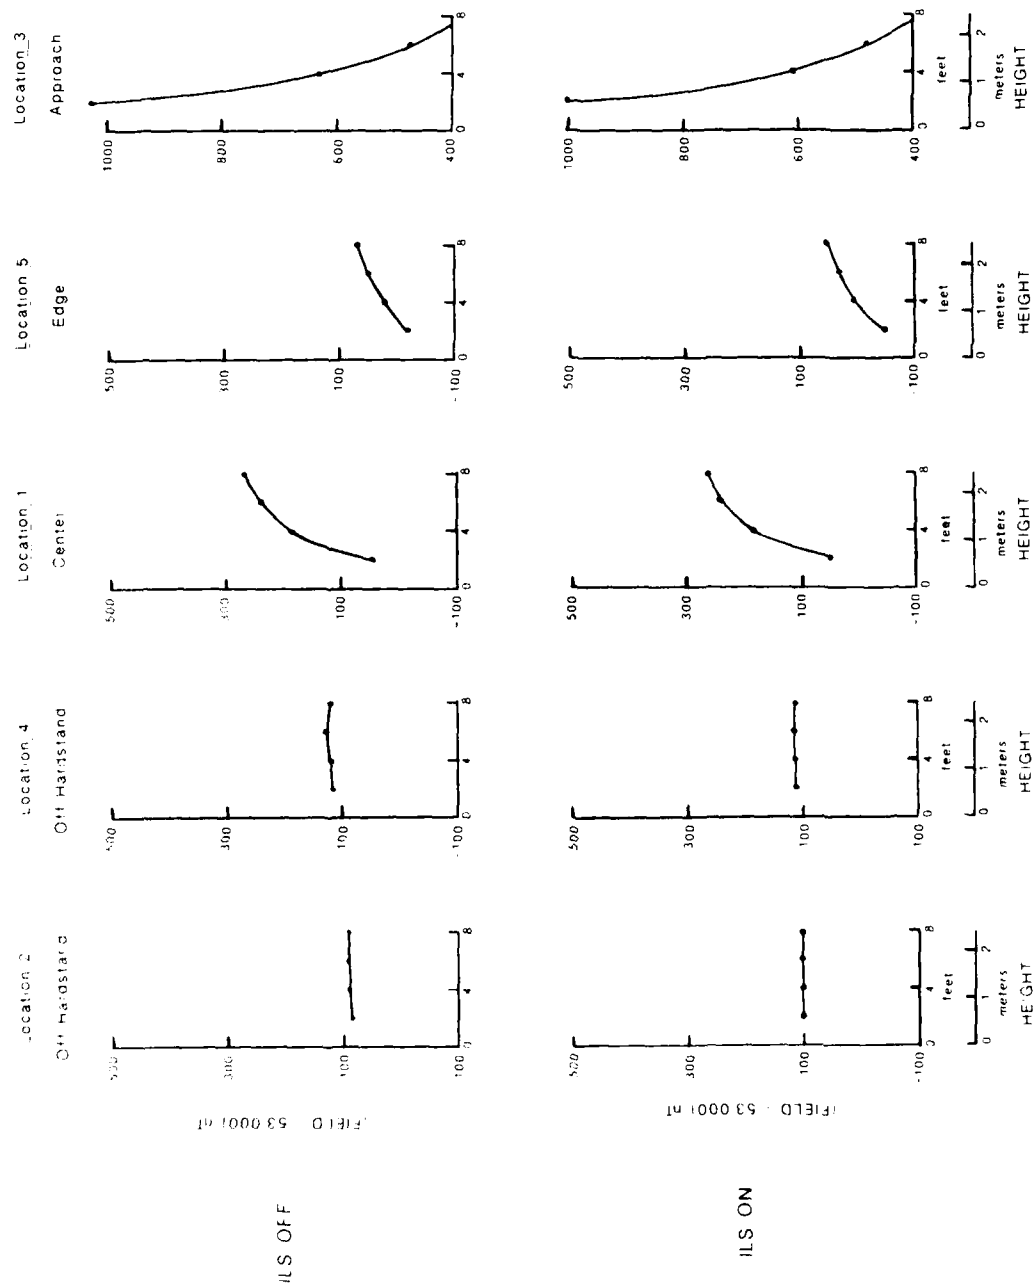
Figure 4. Vertical variations of the magnetic field on and off the hardstand -- ILS on and off

10. Vertical gradients. Measurements of magnetic field strength variations in the vertical direction are shown in Figure 4 for locations 1-5 and for ILS on and off conditions. Three distinct vertical magnetic gradient signatures are displayed. There is no detectable difference in the vertical magnetic gradient for the ILS on and off condition. Locations 2 and 4, off the hardstand, have nearly zero gradient. Locations 1

and 5, on the hardstand, have a large positive gradient; whereas, location 3, on the hardstand approach, has a very large negative gradient. These results are consistent with the magnetic profiles in Figures 2 and 3, in that the magnetic field on the hardstand is anomalous; whereas, the magnetic field off the hardstand is subdued and nearly constant.

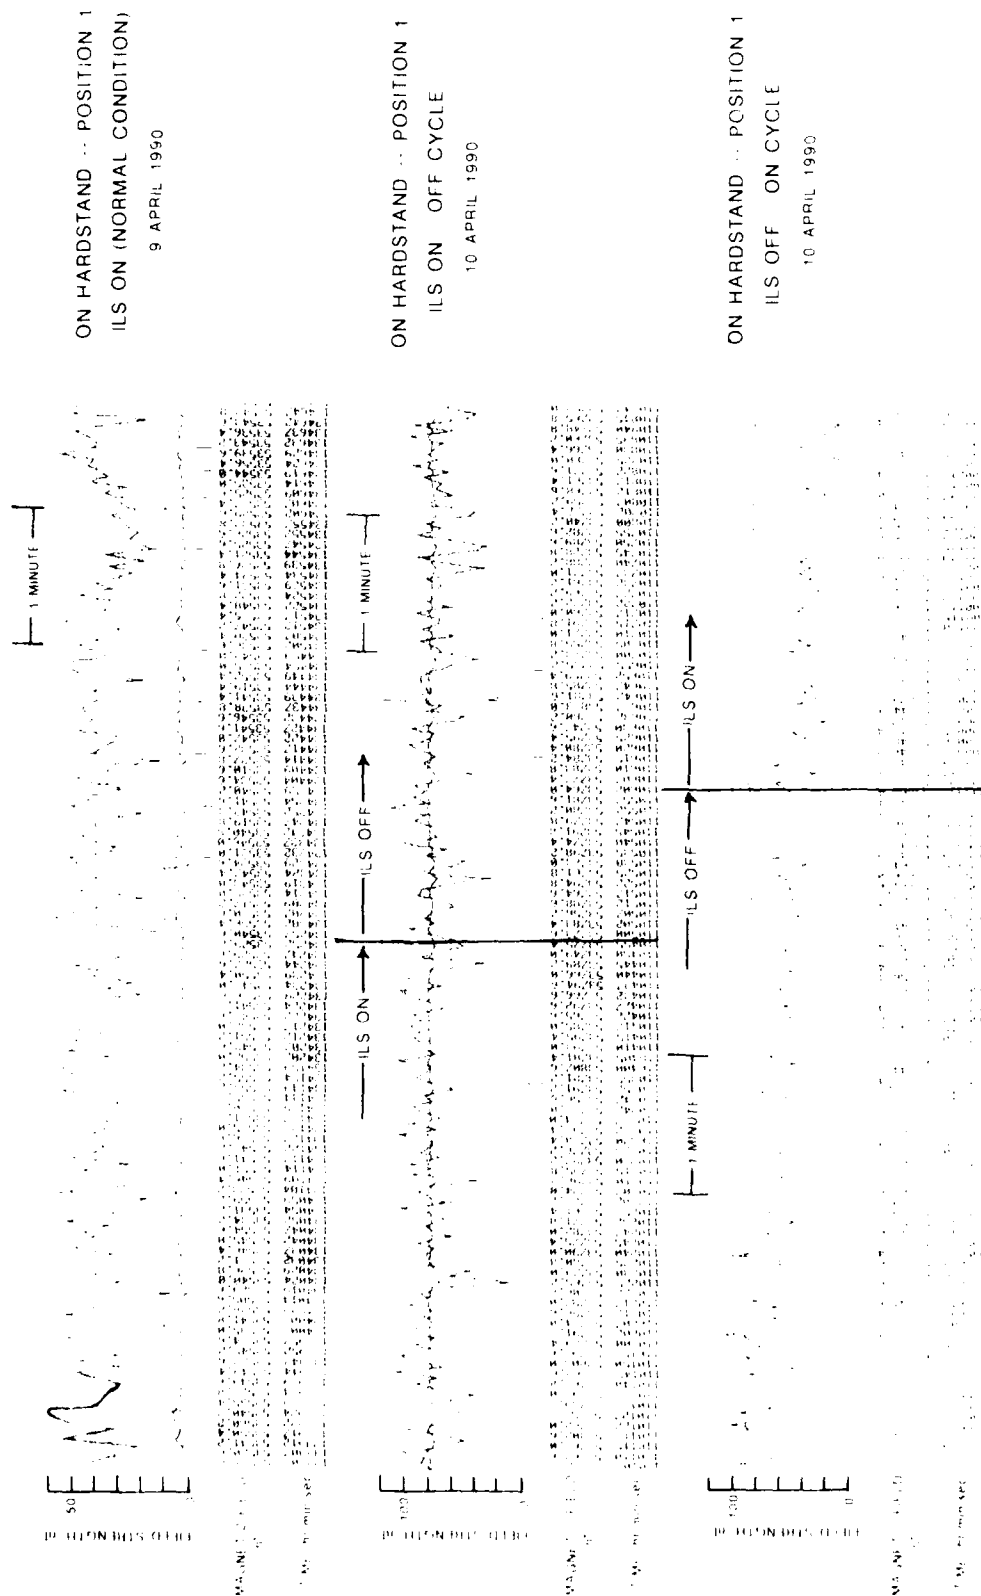
Figure 5. Magnetic field variations with time on the hardstand -- ILS on and off

11. Variations with time. Magnetic field versus time recordings for locations on and off the hardstand are shown in Figures 5 and 6, respectively. The top record in Figure 5 is for 9 April with the ILS operating normally. The remainder of the plots in Figures 5 and 6 are for 10 April and are approximately centered on the time of ILS on/off cycling. No detectable difference is noted between the ILS on and the ILS off conditions. There is, however, a notable difference between locations on and off the hardstand. For location 2, off the hardstand, the record is relatively smooth with 10 nT "spikes" superimposed on a low magnitude cyclical variation with period of 2-3 min; the spikes are likely due to thunderstorm activity in the area on 10 April. The record for location 1, on the hardstand, is extremely erratic and qualitatively appears random. Magnitudes of excursions from a baseline value vary somewhat for the plots in Figure 5 (30-80 nT), but the frequency contents are similar.

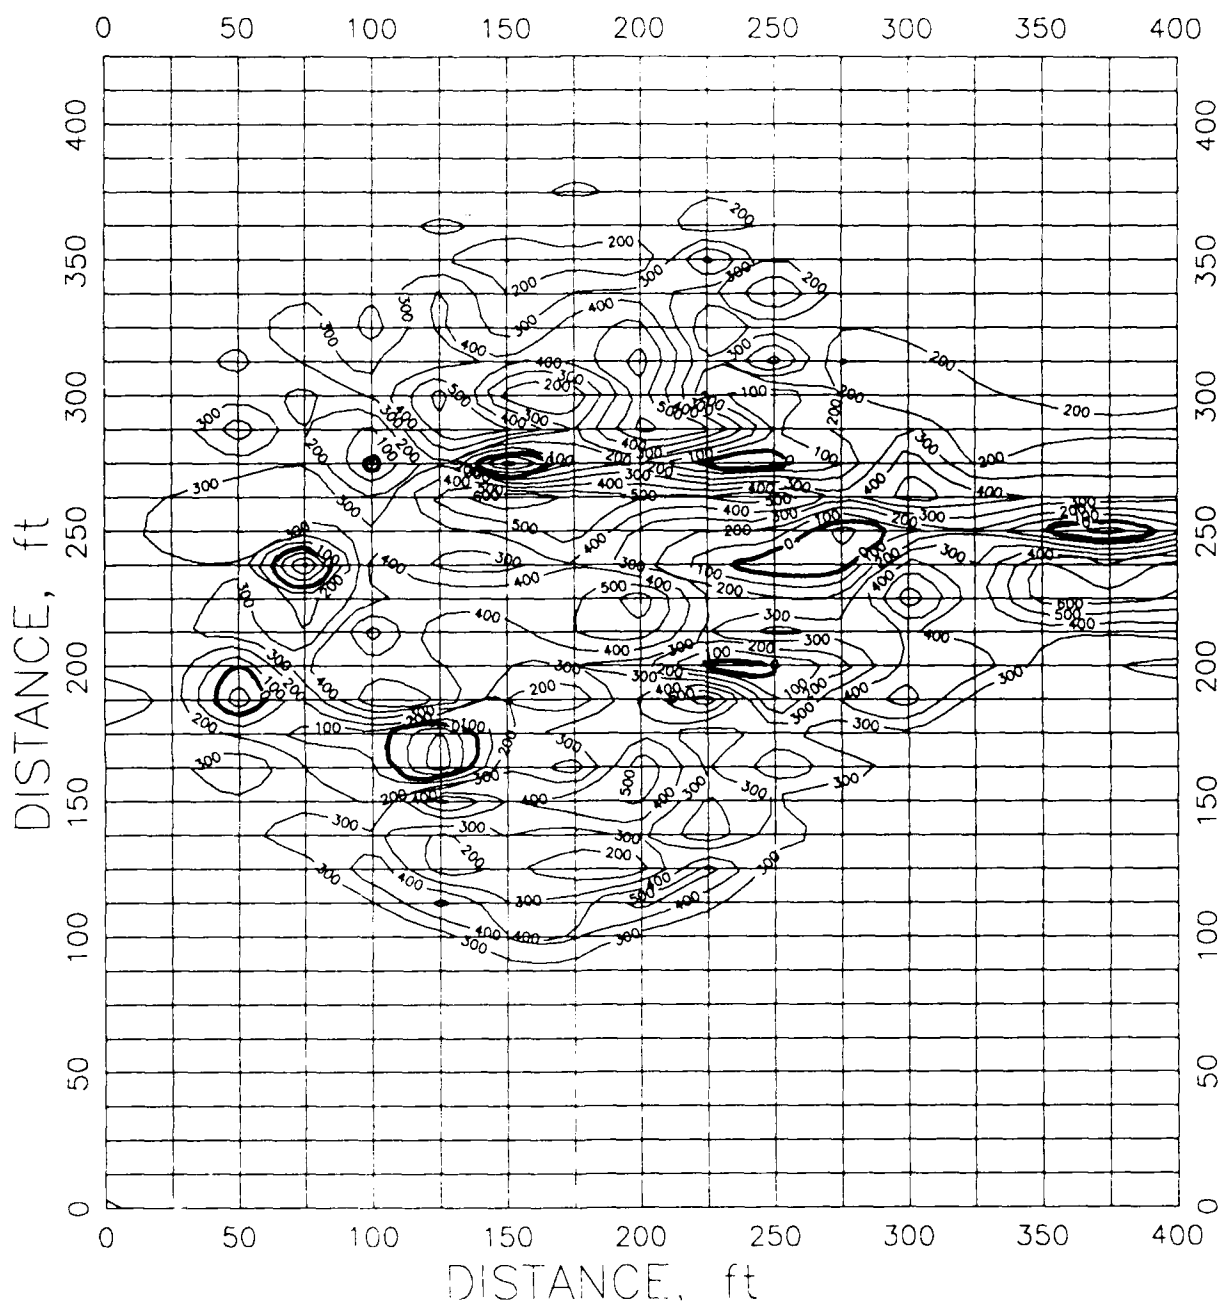
Figure 9. Magnetic anomaly contour map of hardstand area: different contouring parameters than used for Figure 8

14. Figure 9 is a plot of the data, produced with a different set of contouring parameters and with a bold zero contour, which illustrates that although the visual appearance of the map may change slightly the essential features are unchanged. There is no clear pattern to the magnetic anomalies on the hardstand. However, most of the low anomaly values are located around the periphery of the hardstand and in the approach to the hardstand, whereas the central region of the hardstand is predominantly a high anomaly area. A possible trend of low anomaly values extends from approximate locations (50,287.5) to (400,250). There is no readily apparent explanation for such a linear trend of low anomaly values. The only evidence of buried utilities in the area is a small, abandoned electric switch box at location (0,187.5), which is indicated by a small magnetic high anomaly. Base personnel maintain that the inactive line (conduit) to the switch box does not pass under the hardstand.

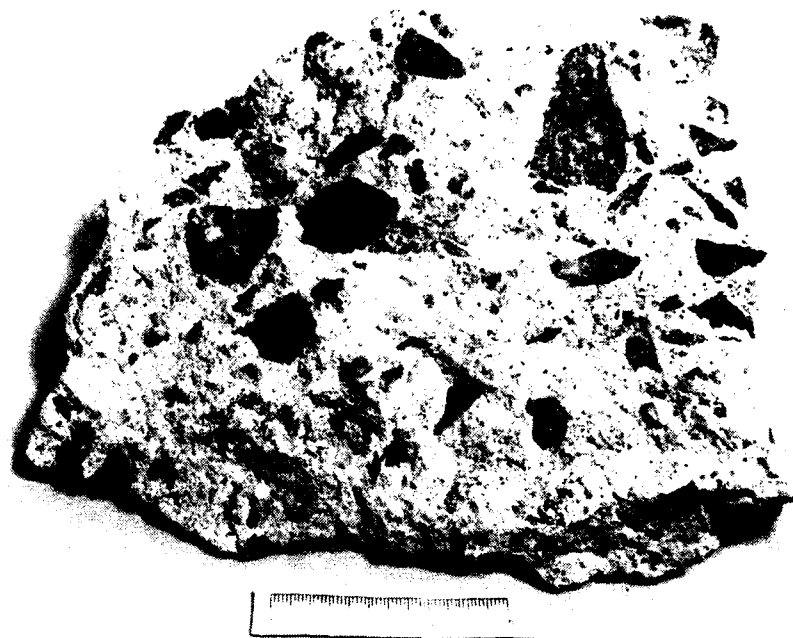
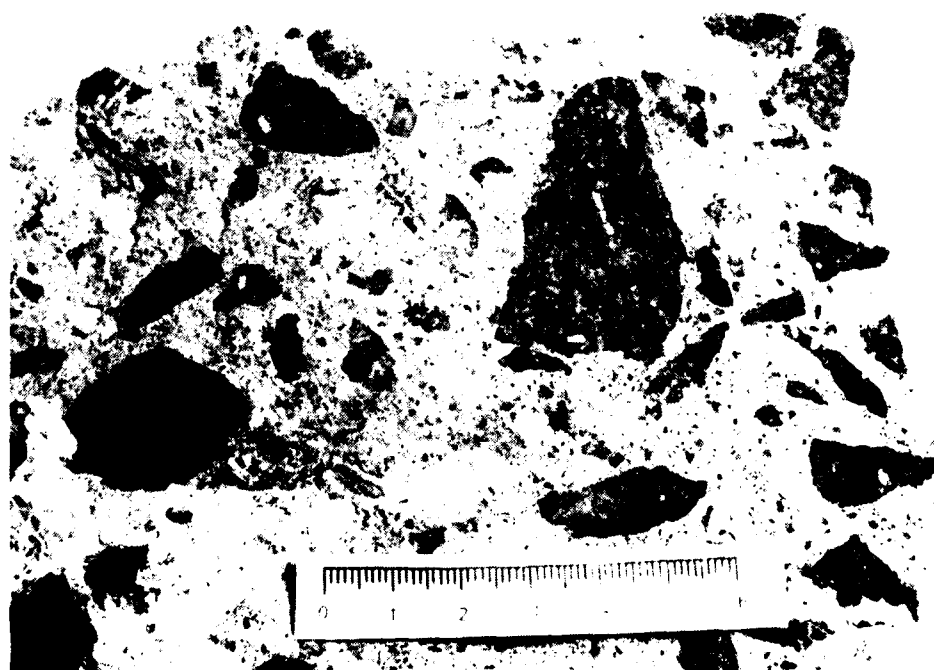
16. Examination of pieces of the hardstand concrete reveals that the aggregate is a dark, igneous material (Figure 10). The aggregate is from a well known local quarry, and is identified as nepheline syenite, which has magnetite as an accessory mineral. The permanent magnetization of the samples is sufficiently large to noticeably deflect a compass needle. The following tabulation lists the magnetic susceptibility of two concrete samples and one sample of shale from the Atoka Formation (local "bedrock") determined by the US Geological Survey, Branch of Geophysics, Denver, Colorado:

Figure 10. Concrete sample from calibration hardstand; aggregate is nepheline syenite, which has magnetite as an accessory mineral

Thus the bulk magnetic susceptibility of the hardstand concrete is 10 times the susceptibility of the shale "bedrock" and the susceptibility of the aggregate is 20 times that of the shale. Even the concrete matrix magnetic susceptibility is 2-3 times that of the shale. The magnetic aggregate in the concrete is the cause of the anomalous magnetic field on the hardstand. The aggregate has a permanent magnetization due to the presence of magnetite, and the permanent field component can have random strength and orientation due to variations in aggregate "density" throughout the hardstand.* Also, the hardstand will tend to "amplify" time variations of field strength due to thunderstorm activity, nearby electromagnetic sources, and solar activity (flares, sunspots, etc.), due to the high bulk magnetic susceptibility.

- a. Remove the present hardstand and construct a new hardstand in the same location using nonmagnetic aggregate; a conservative amount of the hardstand approach should also be removed.
- b. Construct a new hardstand S-SE of the present hardstand location, using the present hardstand for access, and offset by several hundred feet.
- c. Construct a new hardstand at the alternate site indicated in Figure 11, offset by greater than 200 ft from the existing taxiway.

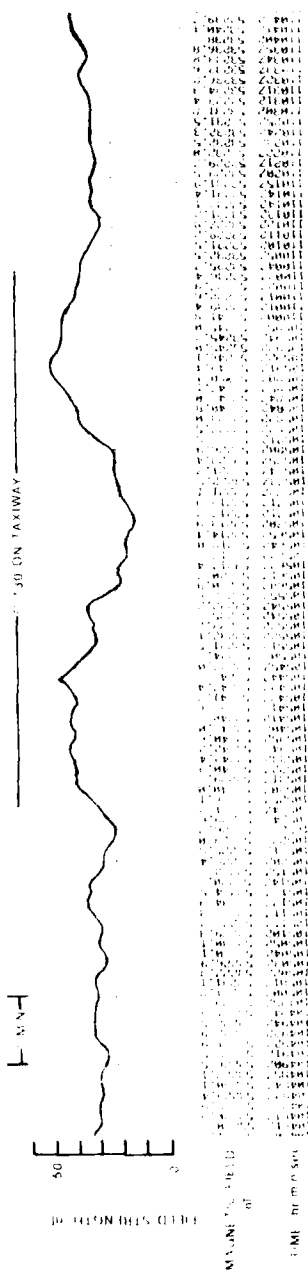
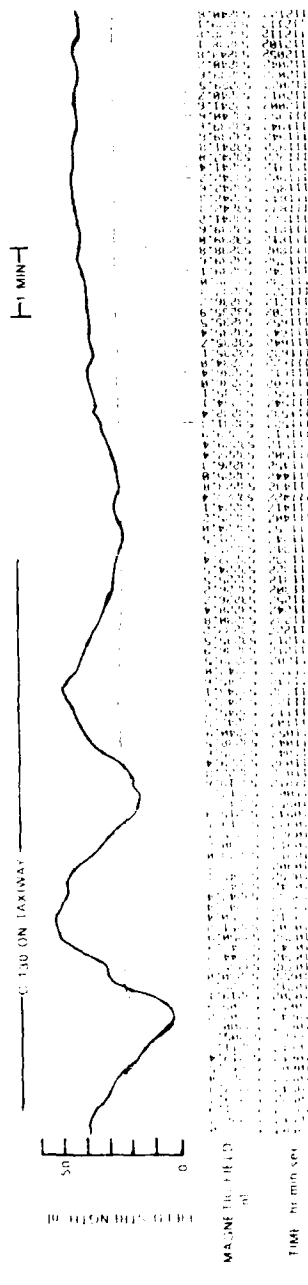
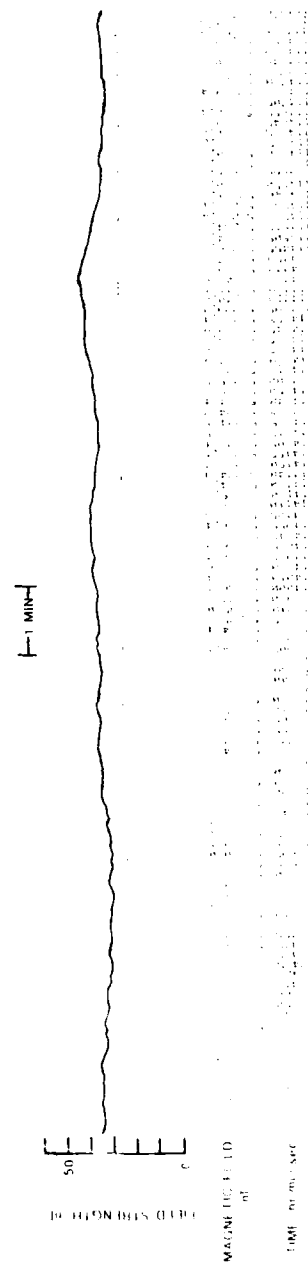
Figure 13. Magnetic field variation with time for two locations at alternate site

19. Magnetic field versus time records for the two locations indicated in Figure 11 are shown in Figure 13. The middle plot is a continuation of the top plot for the location on line II, and the bottom plot is for the location on line III. For the first recording location, 100 ft from the taxiway, magnetic disturbances as large as 25 nT from a baseline are created by C-130 aircraft passing on the taxiway. At the second recording location, 225 ft from the taxiway, variation from a baseline is less than 5 nT, and the signature due to a passing aircraft is not apparent.

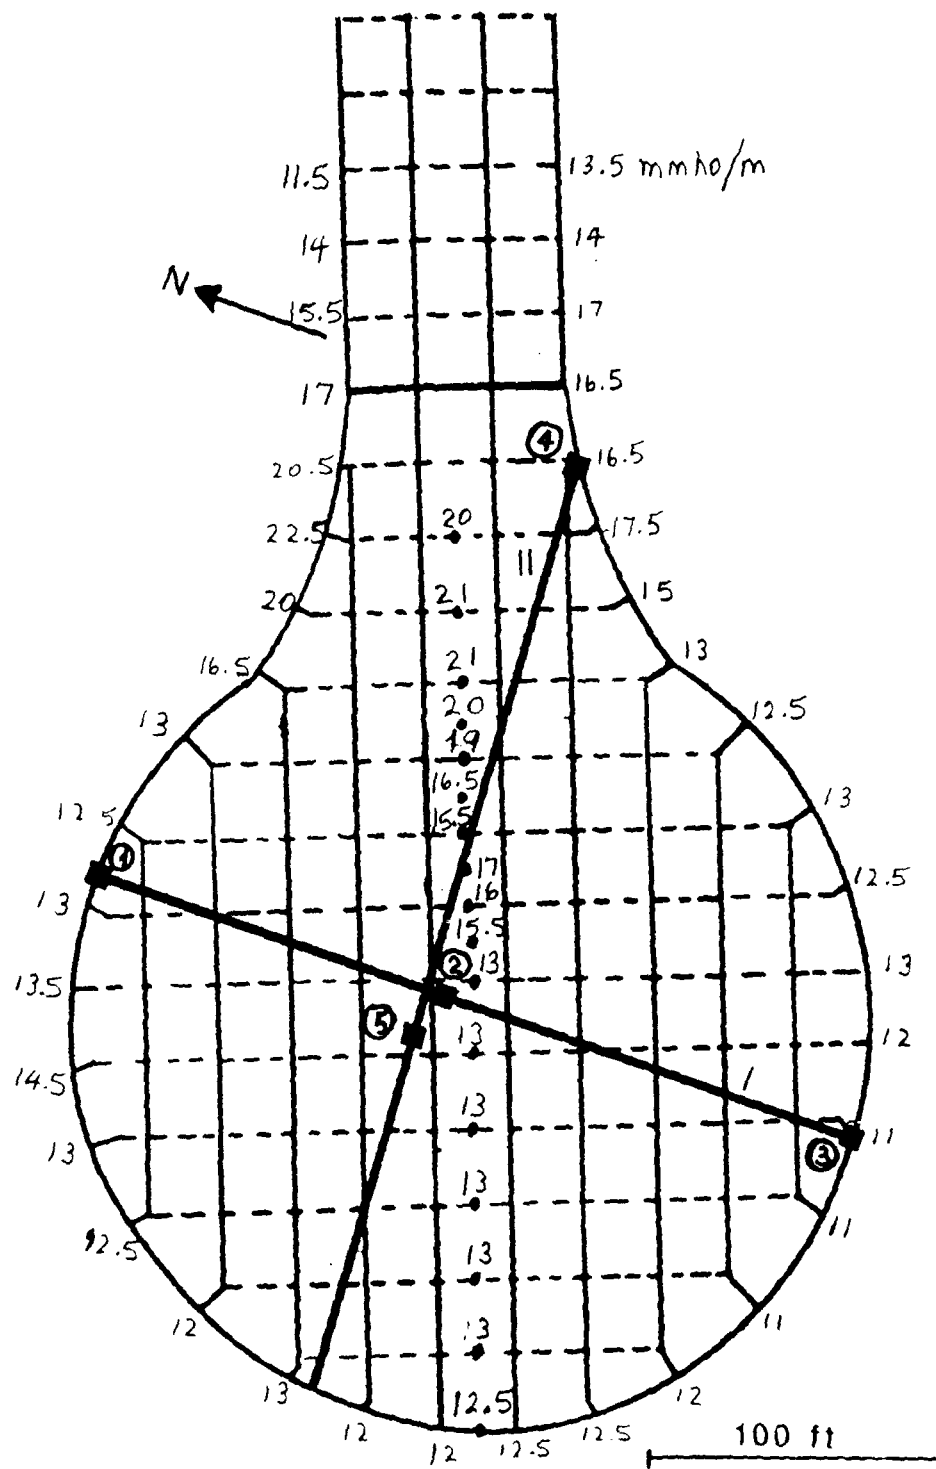
FIGURE 1. GEOPHYSICAL SURVEY LAYOUT AT THE CALIBRATION HARDSTAND

The locations of the geophysical measurements are shown in Figure 1. Lines I and II are N-S and E-W magnetic survey lines with measurements every 25 ft. The squares are locations where magnetic measurements were made as a function of height. The data were acquired with a proton precession (total field) magnetometer with an accuracy of 0.1 nT (nanotesla; the nominal earth's magnetic field strength at the air base is 53,000 nT). Results of the magnetic measurements are shown in Figures 2 and 3. The numbers around the periphery of the hardstand and along a line parallel to the center line of the access taxiway are conductivity values acquired with an electromagnetic conductivity device. The conductivity values represent an averaged conductivity of approximately the upper 20 ft of subsurface material. VLF EM measurements were made at the center of the hardstand and consisted of four scans of the frequency band in directions at 90-deg intervals.

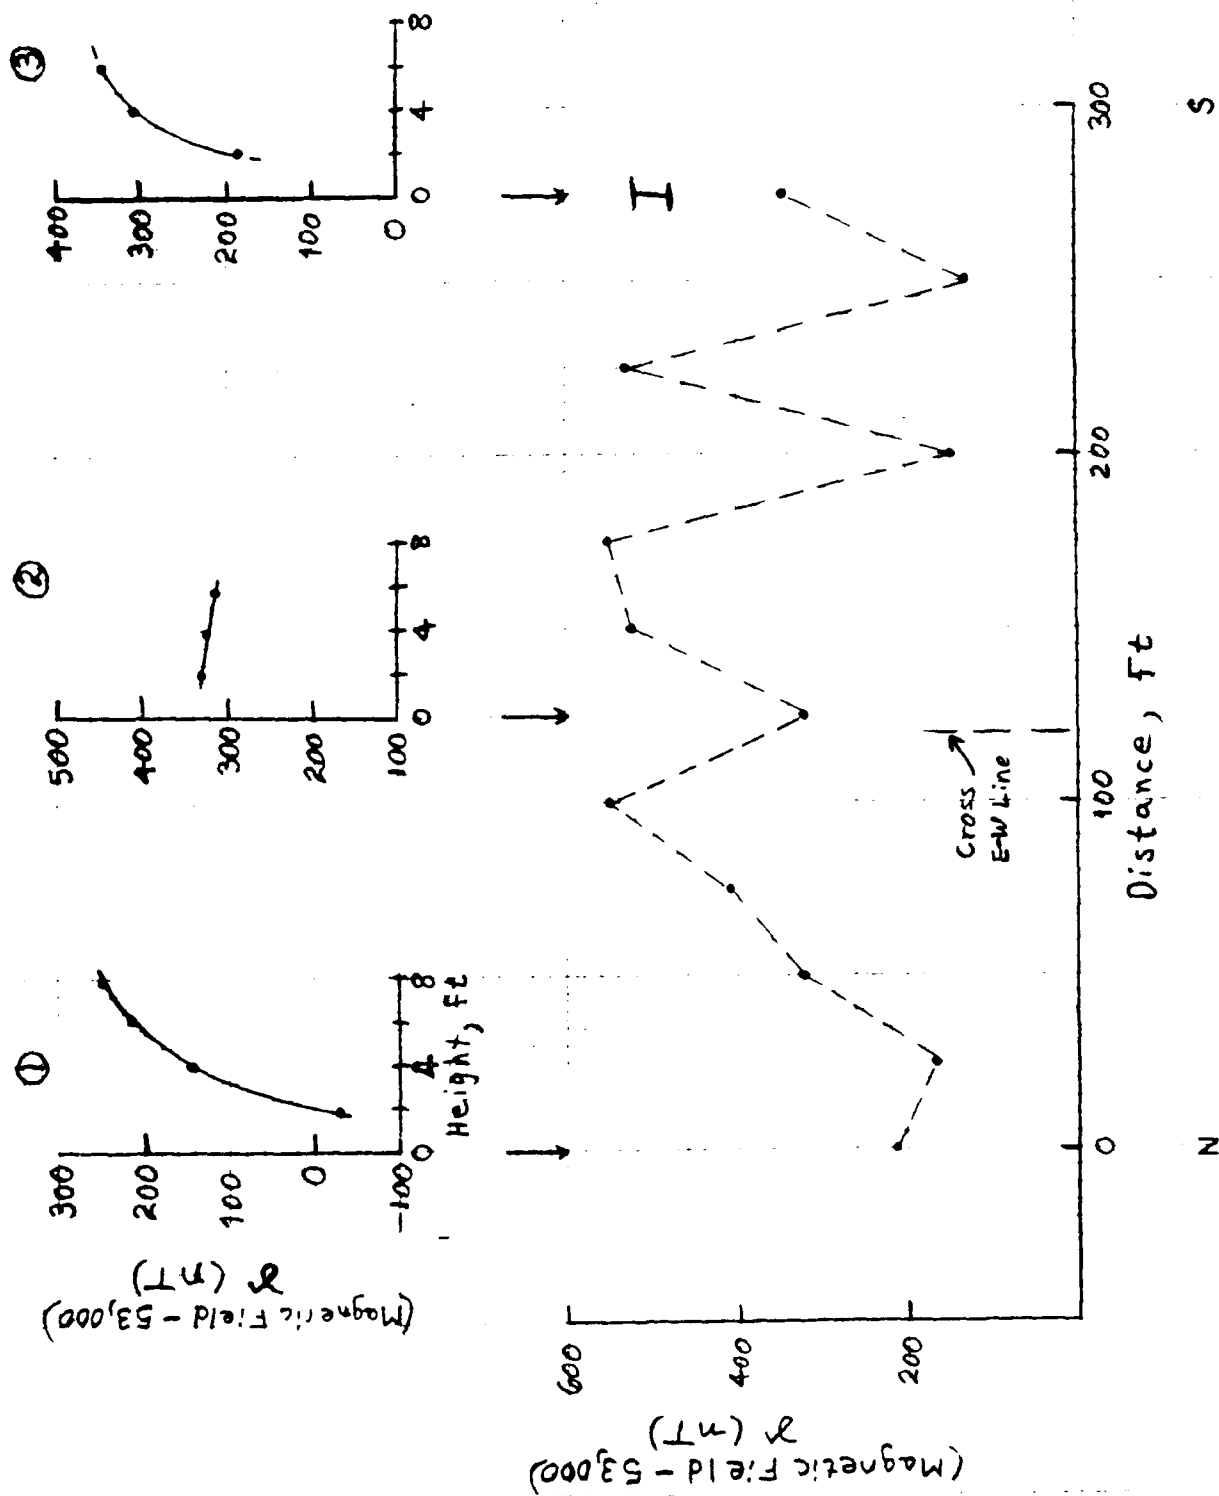
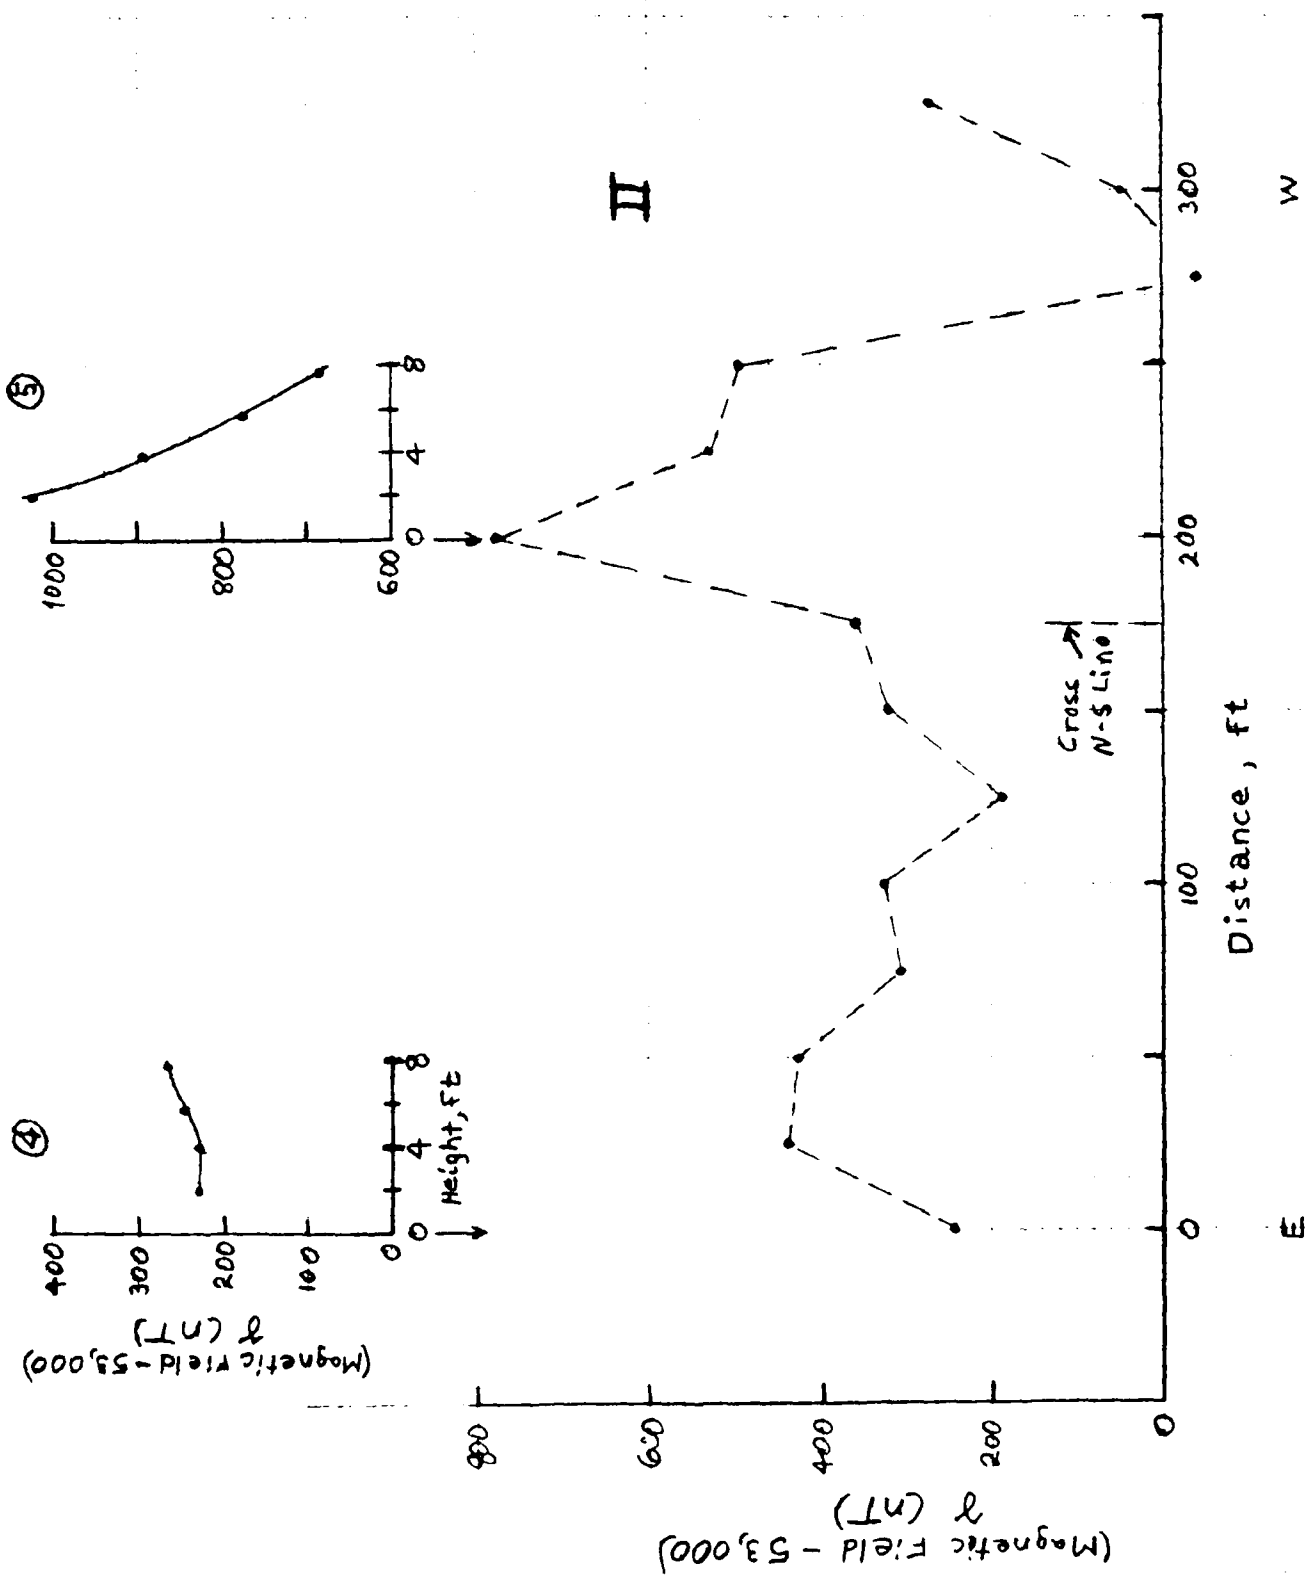
The magnetic survey results in Figures 2 and 3 indicate the nature of the problem at the hardstand location: considerable variation of the magnetic field strength both vertically and horizontally. Horizontally, the magnetic field over the hardstand is characterized by gradients as large as 15 nT/ft, and the field is highly erratic. Vertical gradients vary considerably with location in both magnitude and sign:

A well-defined positive magnetic anomaly occurs with center at location 200 ft of line II (location of anomaly is indicated in Figure 1). The gradient at this location (5) is consistent with a positive anomaly caused by a subsurface source. Based on the width of the magnetic anomaly, the cause of the anomaly could be as deep as 75 ft.
